Aquatic Assessment
&
Habitat Enhancement Plan
Fountain Creek - Soda Springs Park
City of Manitou Springs
El Paso County - Colorado

FIN-UP Habitat Consultants, Inc.

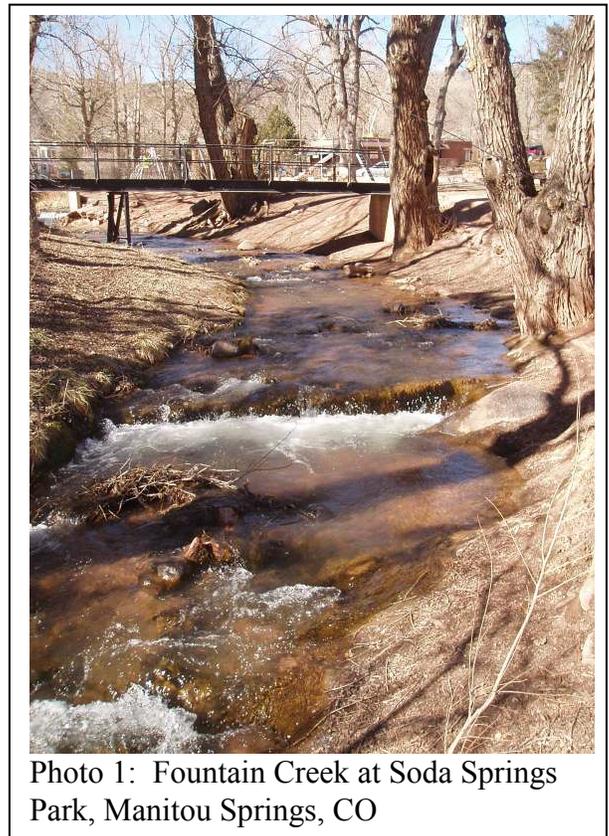
Photo 1: Fountain Creek at Soda Springs Park, Manitou Springs, CO

Reach 11 has been dramatically altered throughout much of its length through channelization and construction of concrete retaining walls on either bank. The middle portion of the reach is characterized by a deeply incised channel through relatively unstable depositional material composed mostly of smaller gravel. The stream exhibits a very narrow valley bottom with minimal riparian green-line, low sinuosity and moderate (2%) gradient, and is classified as a Rosgen G4c. G4 channels tend to be very unstable due to the very high sediment supply available from both upslope and channel derived sources. Several log drop structures are providing a degree of vertical channel stability in the reach (Photo #1).

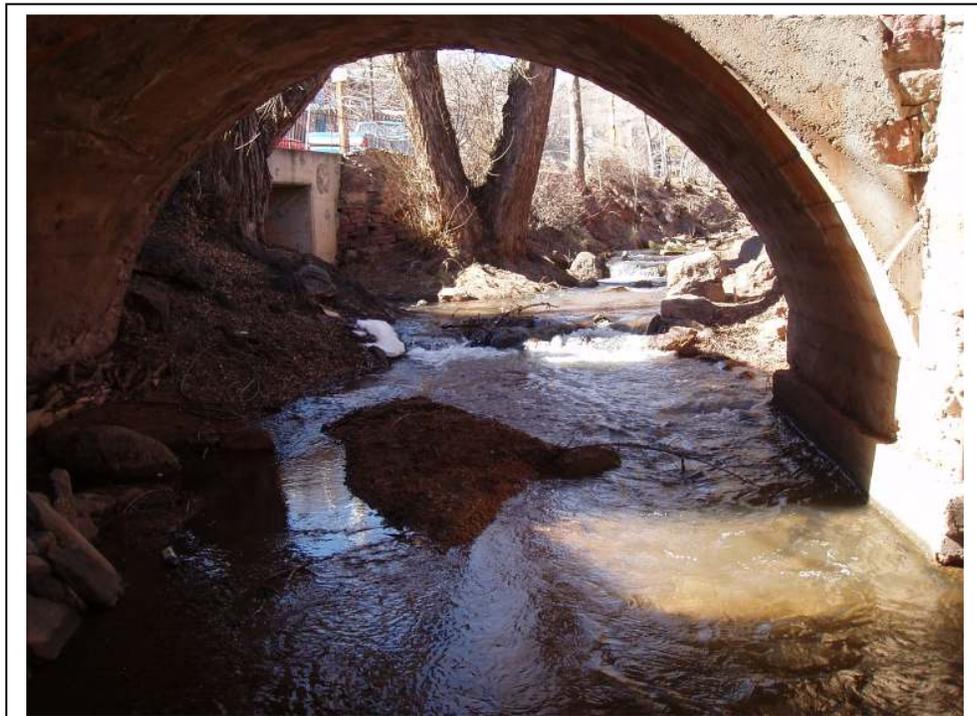
Photo 2: Plunge Pools #3 and 4, near the Confluence with Ruxton Creek.

1. Adjust existing boulders to form a cross vane underneath the stone bridge at Pool #3. Excavate accumulated sediment from the pool and remove from the site.
2. Adjust existing boulders to form a cross vane immediately upstream of the confluence with Ruxton Creek at Pool #4. Excavate accumulated sediment from the pool and remove from the site.
3. Install interpretive signage at the stone bridge.
4. Adjust existing boulders to improve scour and protect eroding stream banks at Pool #5.
5. Use existing boulders to redefine riffle crest at log-drop Pool #7. Construct a rock vane on the right bank, and tie this structure into the existing log to create a cross vane.
6. Install six to eight micro-vortex structures in Riffle #8 upstream and downstream of the steel bridge.

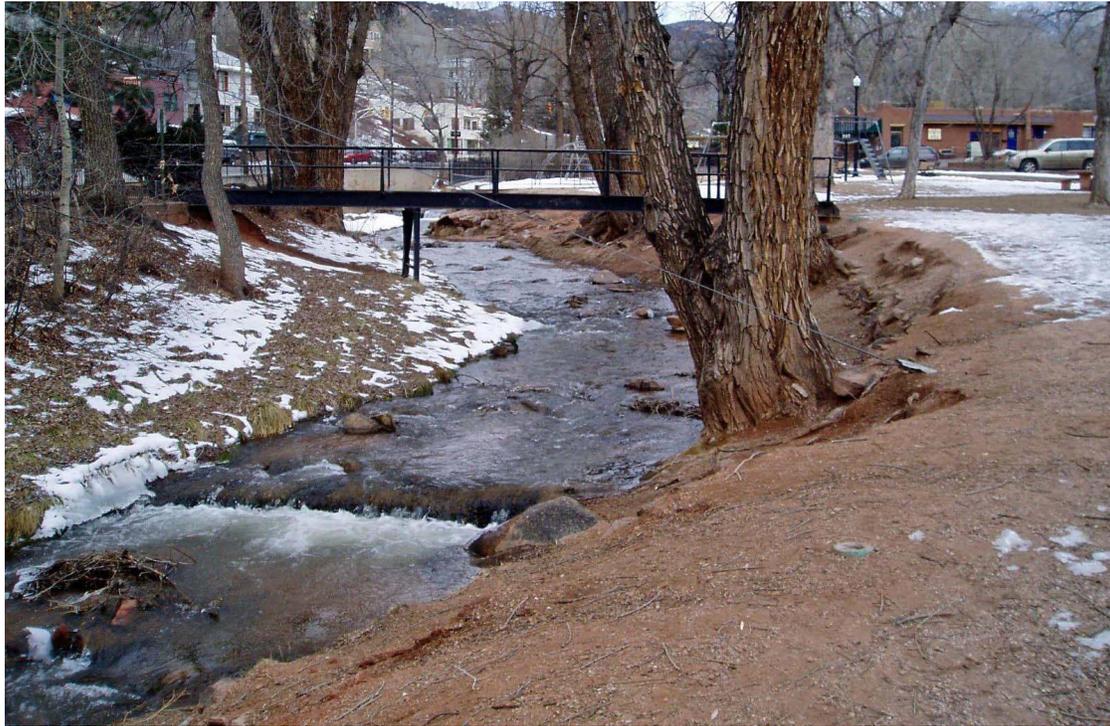
The aquatic assessment indicates that stream bank erosion within Soda Springs Park is a significant contributing factor for sedimentation of pool habitats in the reach. Heavy recreational pressure continues to further erode these banks. Visually and esthetically, the bare gravel stream banks are detrimental to the overall park values, and may constitute a safety hazard, due to the unstable nature of the decomposing granitic material comprising these steep sided slopes.

The assessment identifies 217 feet of unvegetated, actively eroding stream bank on the right (north) side of the stream between Pool #5 and Glide #3 that may be stabilized and revegetated using a combination of techniques (Photo 3). First, the toe-slope along this segment of the reach will need to be stabilized through the anchoring of large diameter wood (10"-16"DBH) and boulder (1/2 - 2/3cy) at the base of the stream bank (see design drawings #5 & #10 - Appendix). This method of toe-slope stabilization will create a small bank-full bench on which riparian plants such as willow and sedge may be planted, further armoring the base of the stream bank. Due to the entrenched nature of the G channel, care must be taken in the installation of these toe slope structures so as not to further constrict the cross-sectional area of the stream channel throughout this segment.

Photo 3: Actively Eroding Stream Banks in the Middle of Reach 11 - Fountain Creek.

In addition to toe-slope stabilization, the upper portion of the right stream bank between Pool #5 and Glide #3 may be revegetated by constructing one or two terraces using existing stone walls and landscape timbers. These terraces will reduce the velocity of storm water entering the creek from the park, and will allow for stabilization with upland woody vegetation such as mountain mahogany, native grasses and sedge. These areas will require additional top soil and erosion control fabric in order to allow the newly planted vegetation to become established.

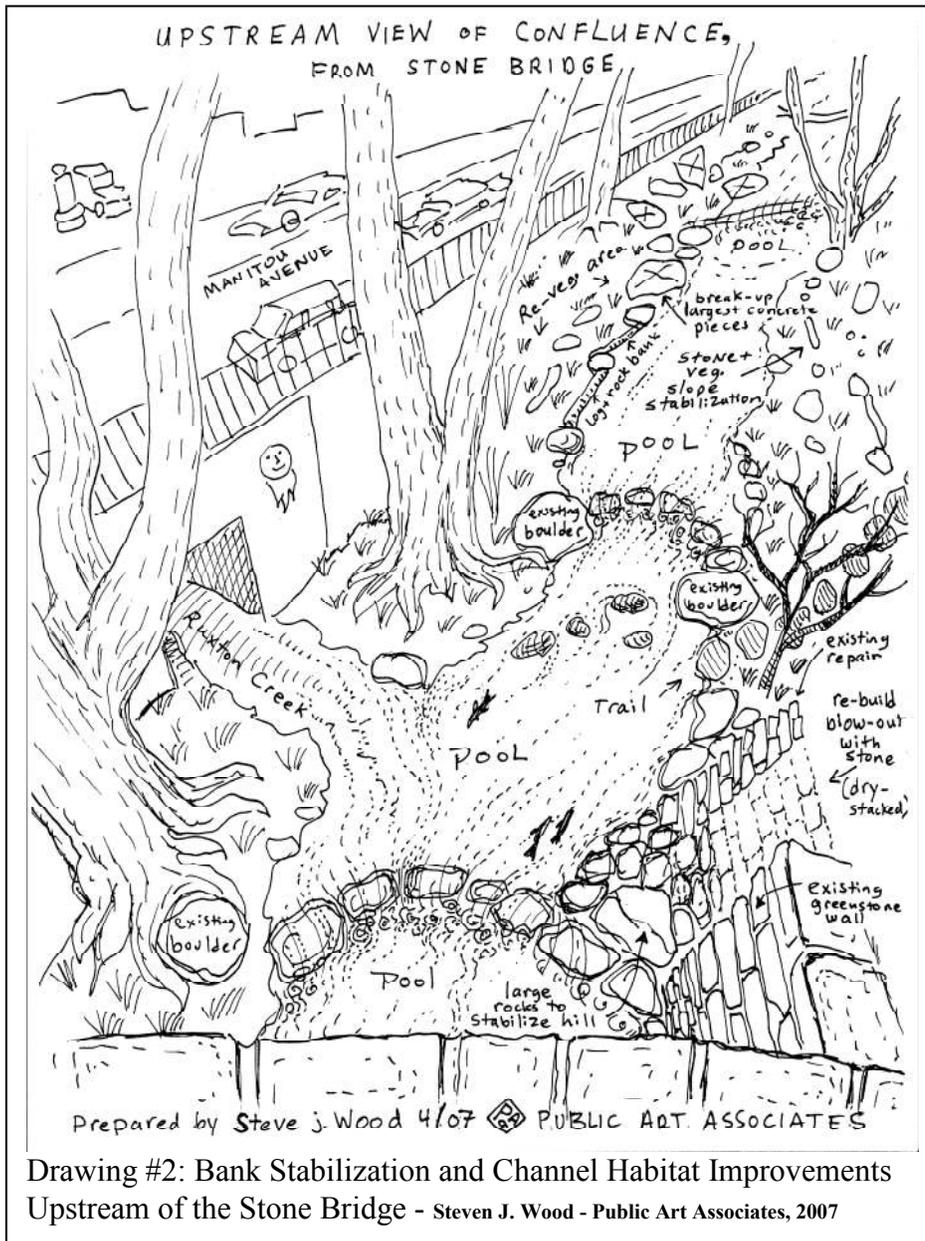
Drawing #2: Bank Stabilization and Channel Habitat Improvements
Upstream of the Stone Bridge - Steven J. Wood - Public Art Associates, 2007

the inherent tendency of this structure type to over-widen the stream channel, these habitats occupy only a very small length along the stream channel. Additionally, one of these log drop structures currently protects a partially exposed utility pipe crossing the stream channel. The log drop structure immediately downstream of this structure has failed, causing the channel to head-cut back to this log drop structure. At present, the log drop is undercut approximately one foot, and is at risk of failure.

The boulder associated plunge pools in the vicinity of the stone bridge and the confluence of Ruxton Creek may be further improved by adjusting the existing boulders to improve scour. Minor dredging of deposited sediments may be required in Pool #3 and Pool #4, and may be accomplished at the same time as the adjustment of the boulders. Any sediment excavated from the channel will need to be completely removed from the site and stored in a location consistent with federal and state regulations. Enhancement of Pool #3 and Pool #4 will provide excellent fishing viewing opportunities for park visitors entering the park along the stone bridge, and an interpretive sign describing the stream ecosystem and enhancement project should be considered here (Artists Drawing #2).

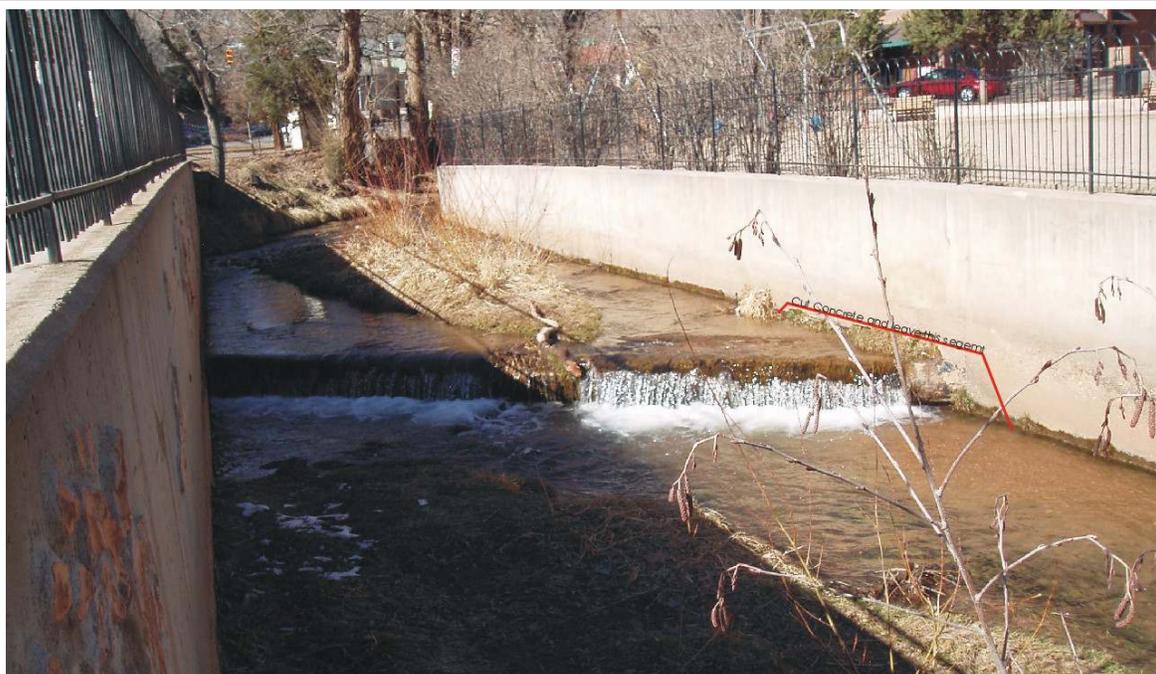
Photo 4: Playground Retaining Wall and Utility Crossing at Log Drop Pool 9

9. Reinforce existing log-drop structure protecting utility crossing at Pool #9 through construction of boulder cross vanes to create a continuous pocket water cascade between Pool #9 and Glide #3.

power during flood events. We propose to remove approximately 150' of the concrete wall, from Glide #3 upstream to Glide #4. Care will need to be taken in demolition of the concrete wall, to protect the historic wall immediately upstream and the utility crossing at Pool #9. At the utility crossing, it may be best to cut the wall at the bank-full elevation, and leave the segment anchoring the log and pipe in place (Photo 4). We recommend that the wall be cut at a downward angle where it ties to the existing stone wall to provide stability for this structure (Photo 5). The right stream bank will need to be sloped back to a similar angle as the downstream restored stream bank in Priority #1, and stabilized using the same toe-slope and revegetation techniques described above. The willow covered island upstream of Pool #9 can be removed, and the vegetation will be transplanted along the newly constructed stream bank. Two additional stream access paths have been identified to be installed in this segment to provide for visitor access to the stream.

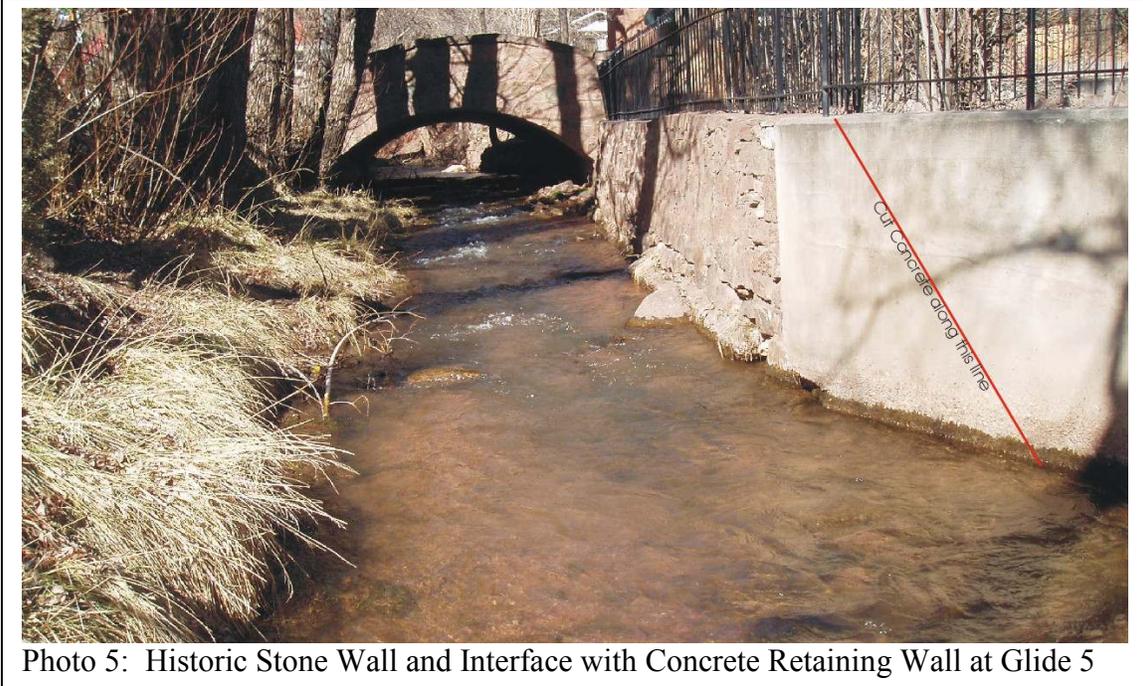
Photo 5: Historic Stone Wall and Interface with Concrete Retaining Wall at Glide 5

11. Install a boulder cross vane at Glide #5, to further augment pool habitat in the reach. Integrate the structure with the existing boulder embedded in the historic stone wall on the right bank.

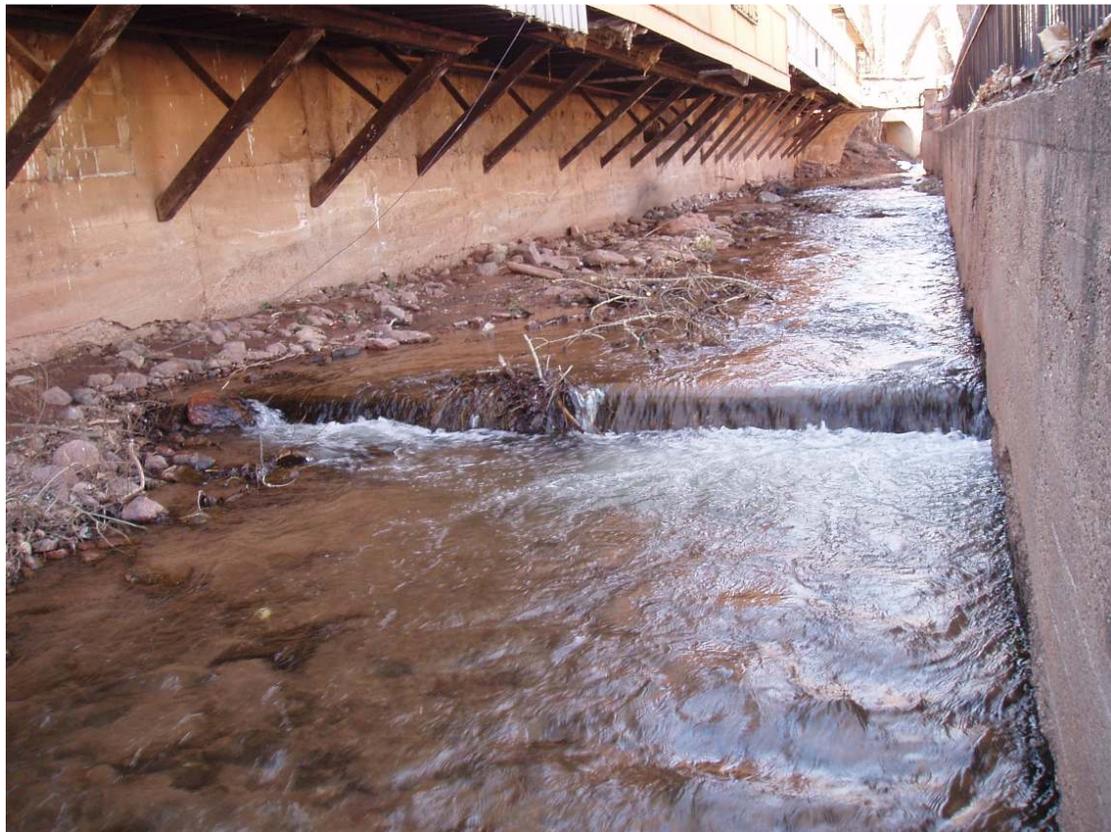
Improvements in this segment of the reach represent the greatest challenge for aquatic enhancement in Soda Springs Park. The stream has been straightened and channelized by concrete retaining walls on either side of the channel (Photo 6). Useable aquatic habitat is extremely limited in this segment, and the foundations of several of the buildings overhanging the channel on the left bank appear to be threatened by high flow shear stress. Enhancing the stream through this segment may help reduce some of the foundation erosion risk along the left bank, and provide a unique fish-viewing experience for customers of businesses such as Kinfolks, the Ancient Mariner, and Mate Factor, where the windows in the back of these establishments look directly down on the stream. While there is somewhat greater risk in working in this segment, the potential benefits may warrant consideration in implementing this portion of the enhancement project.

Photo 6: Concrete Retaining Wall Channel Downstream of the Stone Bridge - XS#1.

We propose to enhance the natural habitat features already present in this segment through strategic placement of small cross vanes, J-hook vanes and micro-vortex structures. Full channel cross vanes will provide vertical stability in the channel, helping to prevent undercutting of the building foundations. The smaller J-hook vanes will be installed along left bank to direct the thalweg away from and reduce sheer stress along the foundation walls, and to protect a utility crossing immediately upstream of Pool #2. Micro-vortex rock clusters may be installed within the riffle meso-habitats to provide critical velocity shelter and holding areas for trout along this severely confined segment (Artists Drawing #3).

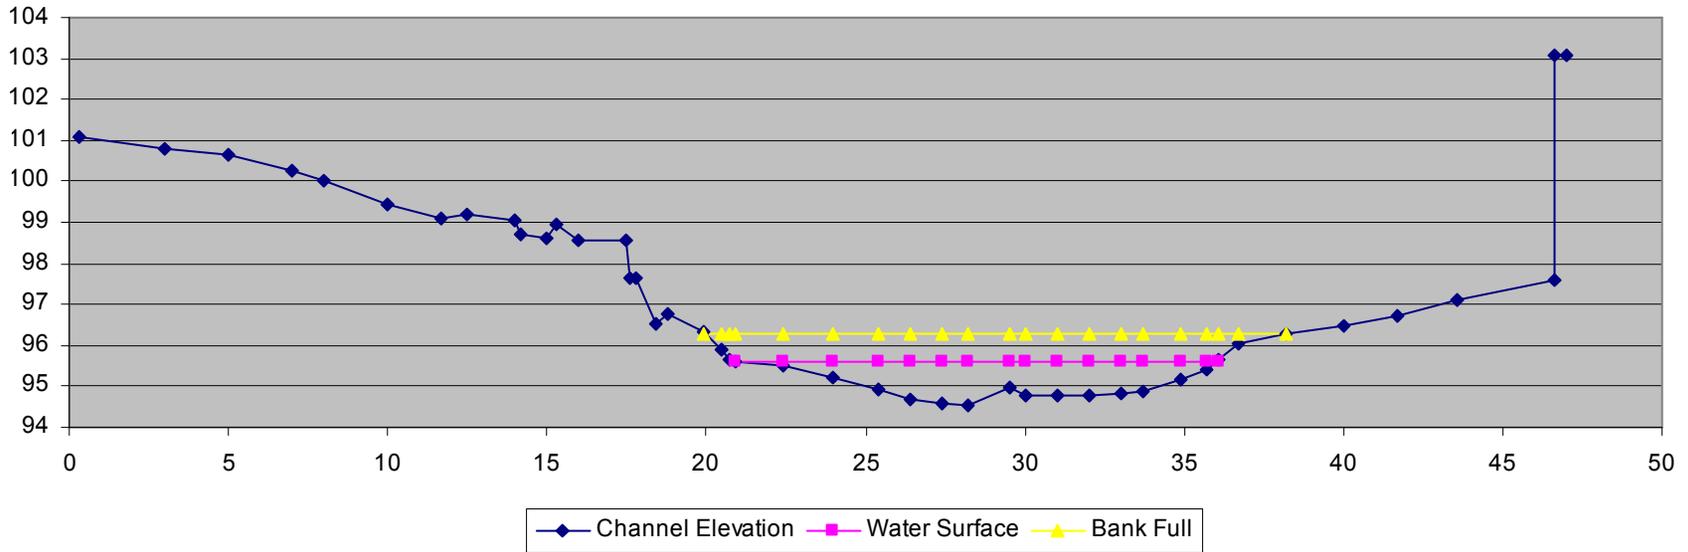
Cross Section #6 @ Glide 3 (Blown Out Drop Structure)

8. Reconstruct the failed log drop structure at Glide #3 through installation of a boulder cross vane. Excavate accumulated sediment from the pool and remove from the site.

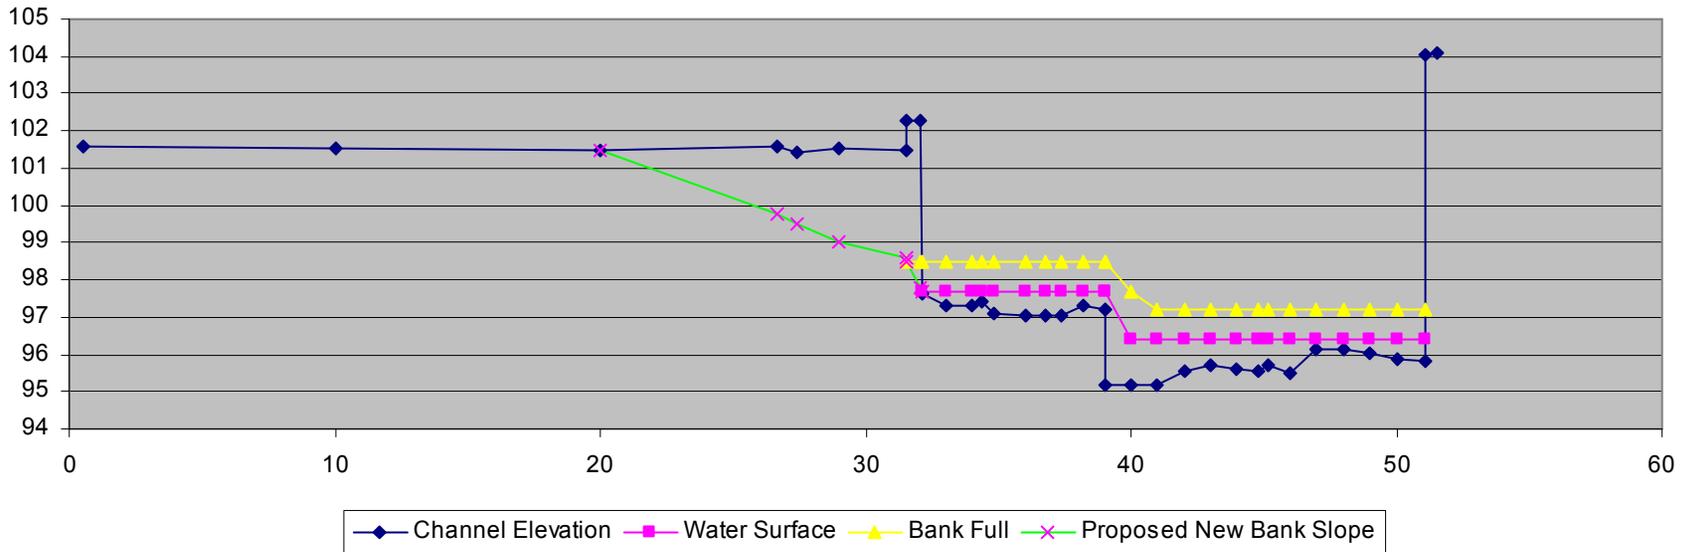
Cross Section #7 @ Pool 9 (Exposed Utility Pipeline)
