STREAM CHANNEL STRUCTURE DRAWINGS

PHOTOGRAPHS OF TREATMENT TYPES

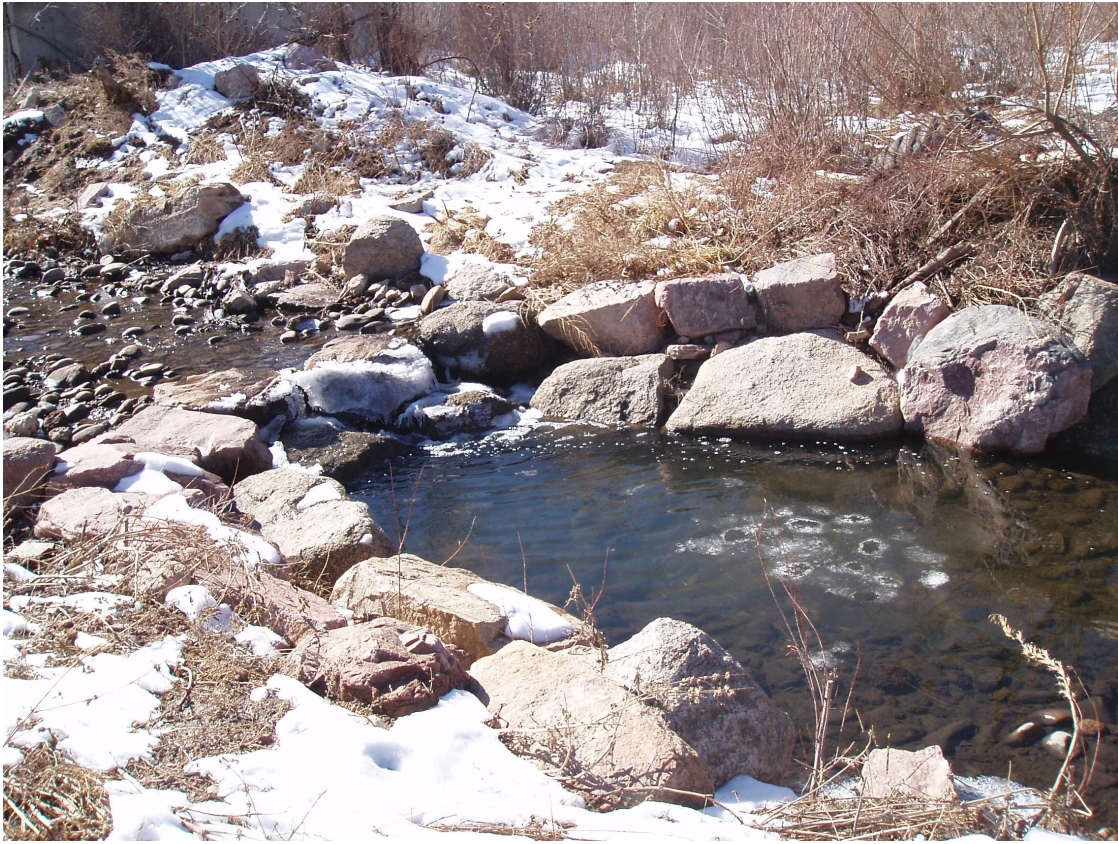
Cross Vane Structure on Cheyenne Creek below I-25 Overpass. Colorado Springs, El Paso County, Colorado

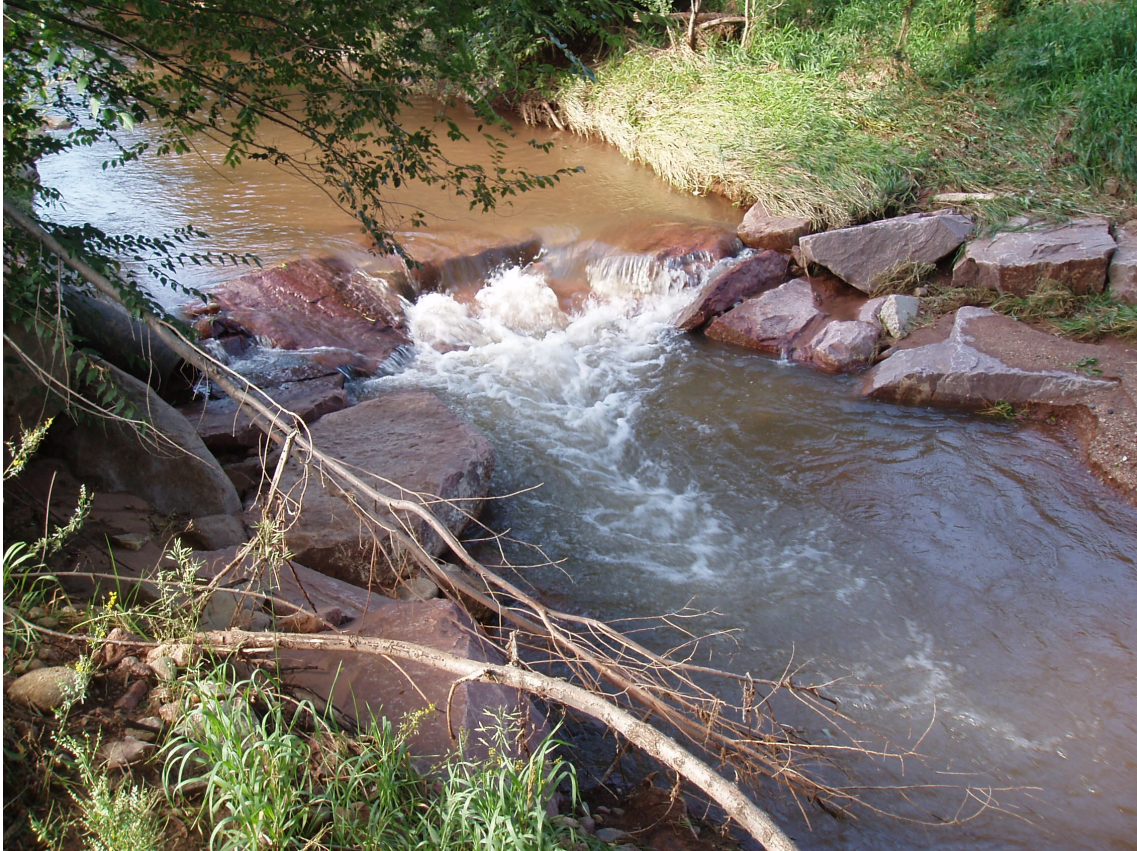
Cross Vane Structure on Fountain Creek below 21st Street Bridge, El Paso County, CO.

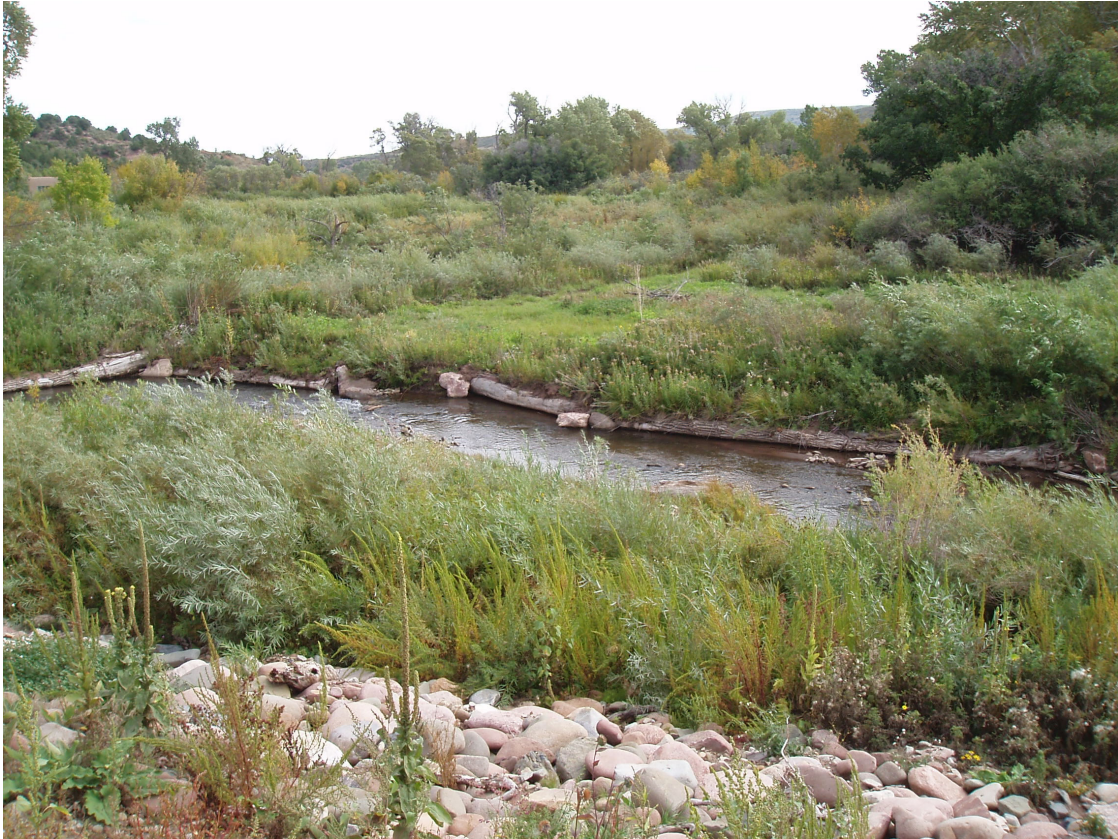
Cottonwood trees used as toe-slope stabilization with riparian benches. Cucharas Creek, Huerfano County, Colorado.

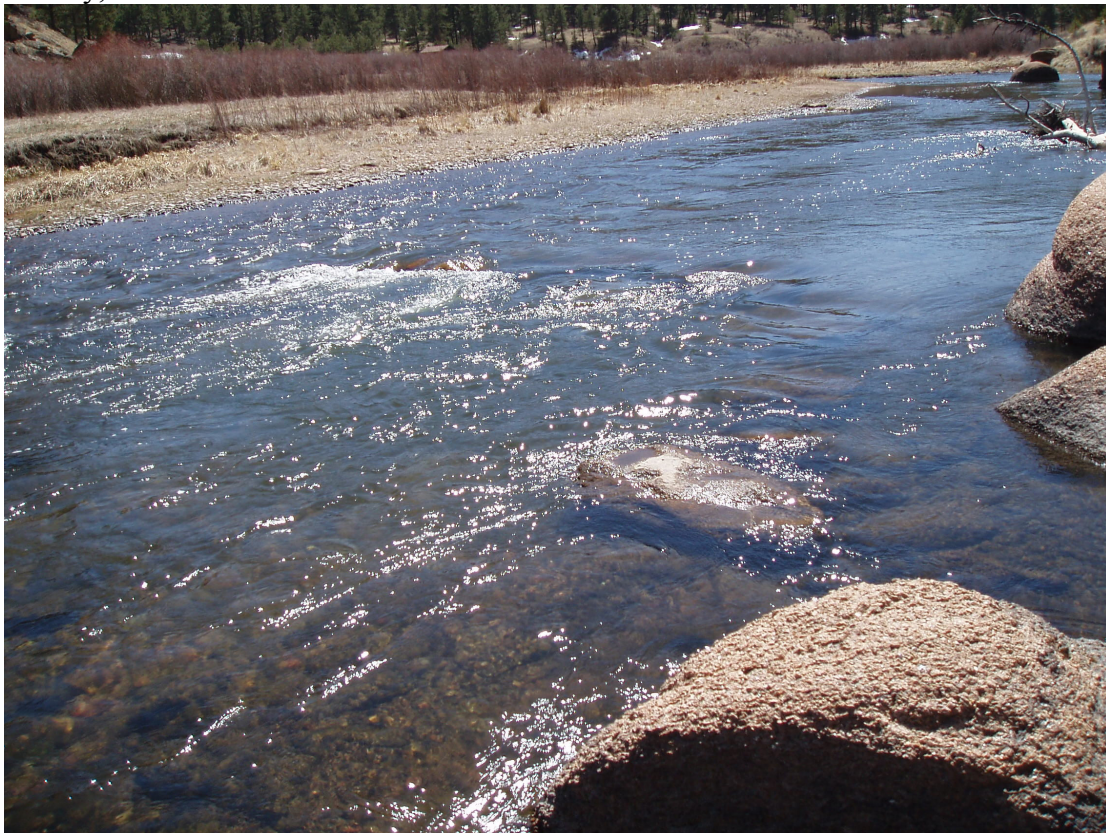
Boulders placed in clusters to create pocket water micro vortex habitats. South Platte River, Park County, CO.

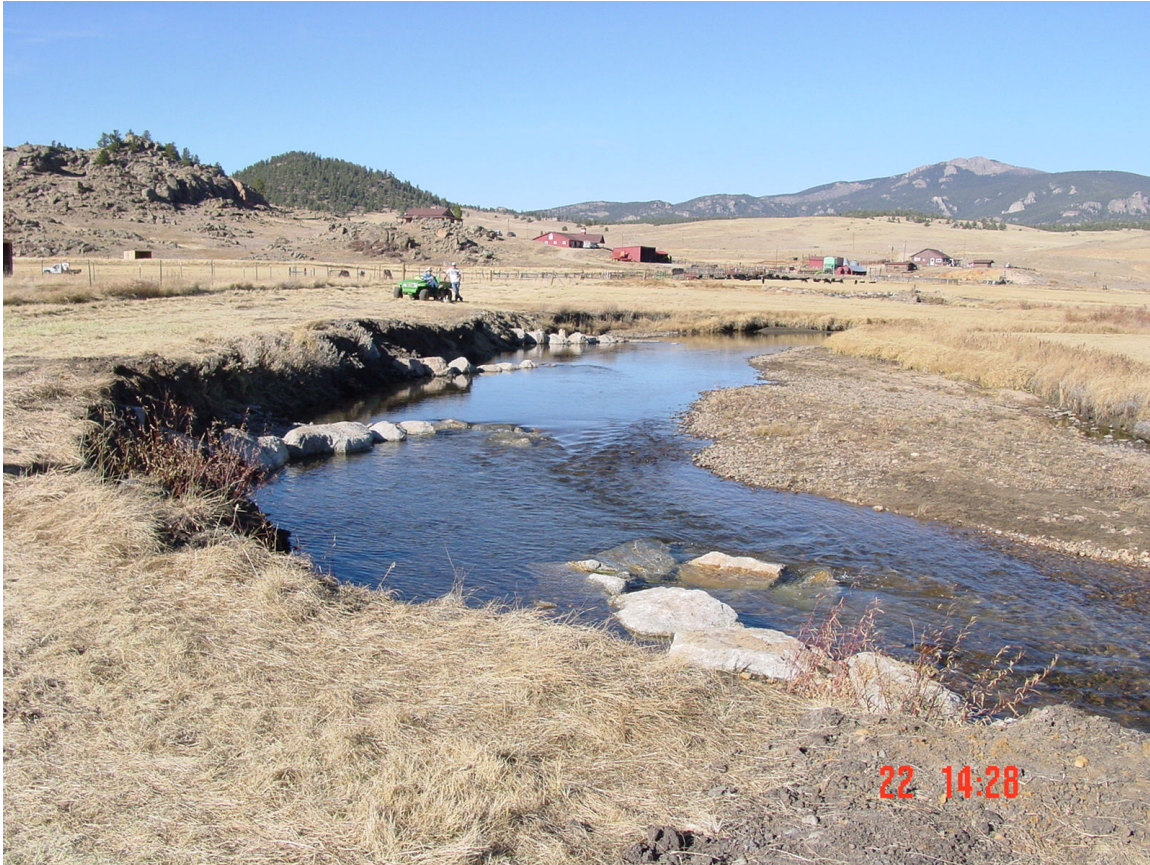
Eagle Rock Ranch - Rock J-Hook Vanes installed to protect stream banks and adjacent road,, 2003.

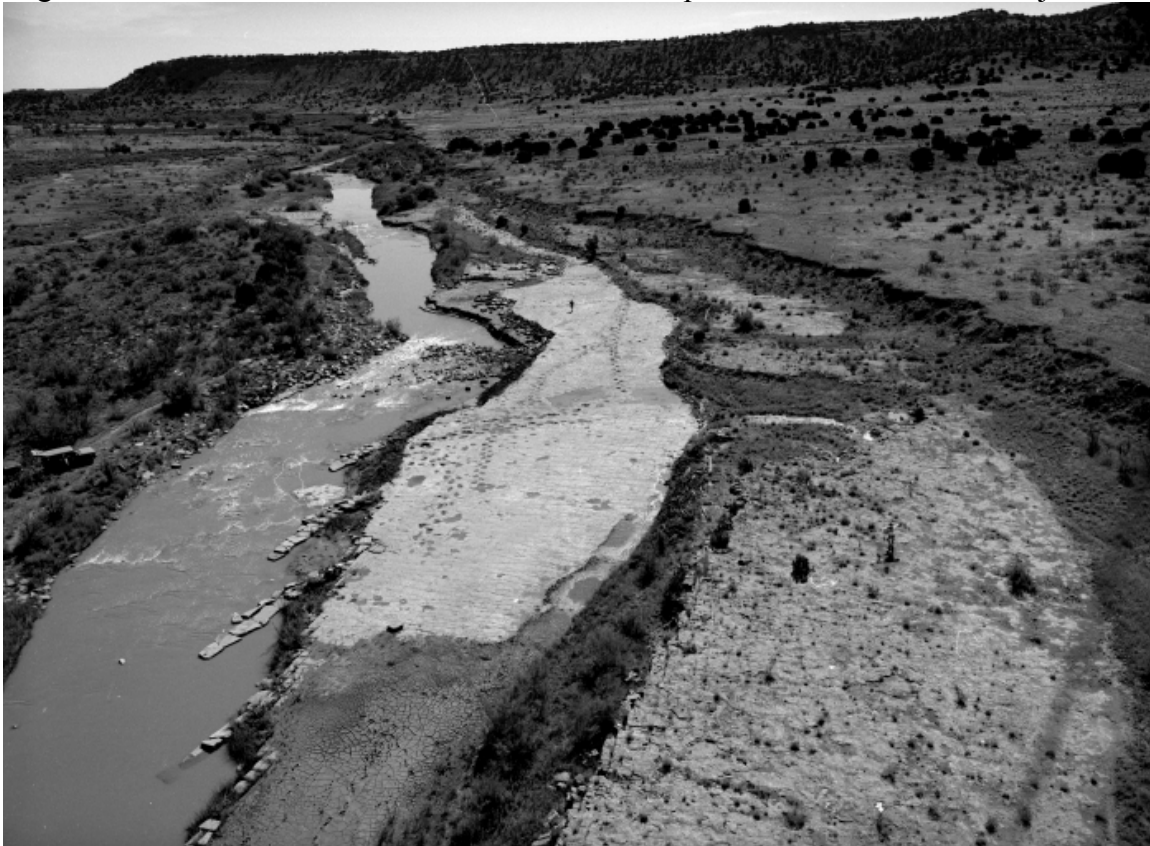
Picketwire Canyonlands, SE Colorado - Rock vanes used to protect dinosaur trackway. These structures were installed in 1998, and survived a 100 year event the following spring. Note the deposition and new willow vegetation taking hold in between the structures.
