Lake Shoreline Stabilization
& Enhancement Project
Elk Mountain Ranch
Carbon County, WY

FIN-UP Habitat Consultants, Inc.

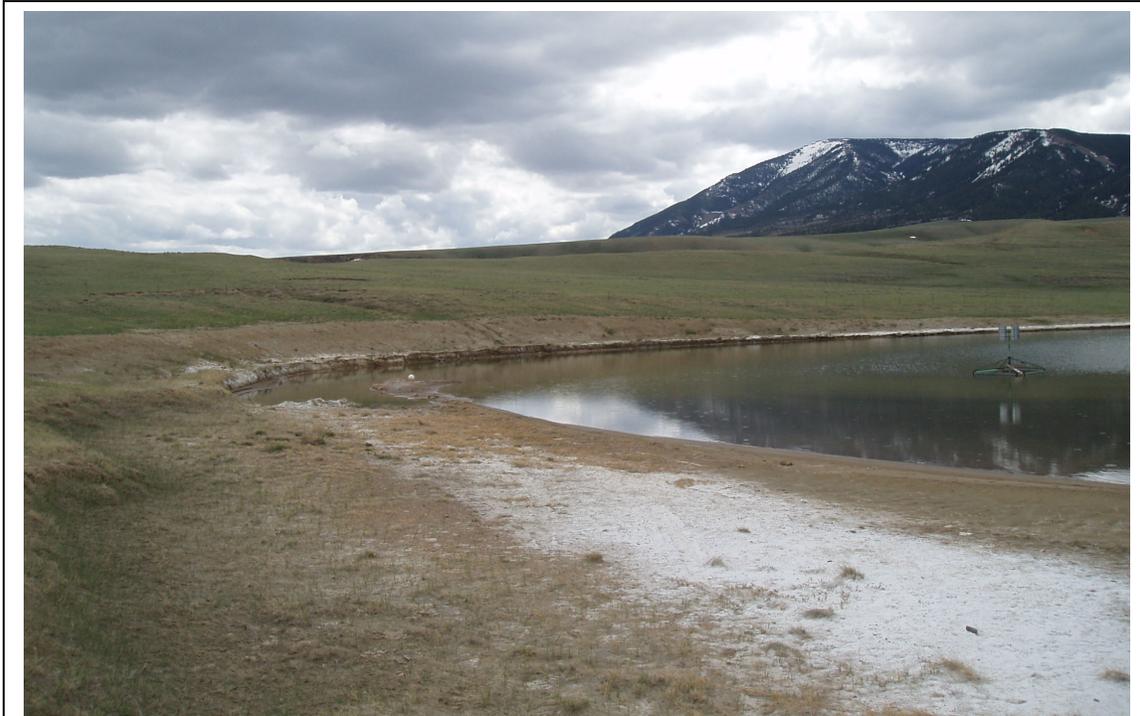
Photo 1: Southeast shoreline of Arapaho Lake..

Arapaho Lake exhibits severe erosion along its southeast shoreline and along the island constructed on the north side of the lake.

Approximately 700 feet of the lake shoreline on the southeast and south side will need to be treated using the log toe slope stabilization techniques described in the preceding section (Map 3). Additionally, the barren upland slope above the eroding shoreline on the southeast side of the lake will require stabilization and re-vegetation using either geotextile or coconut jute fabric.

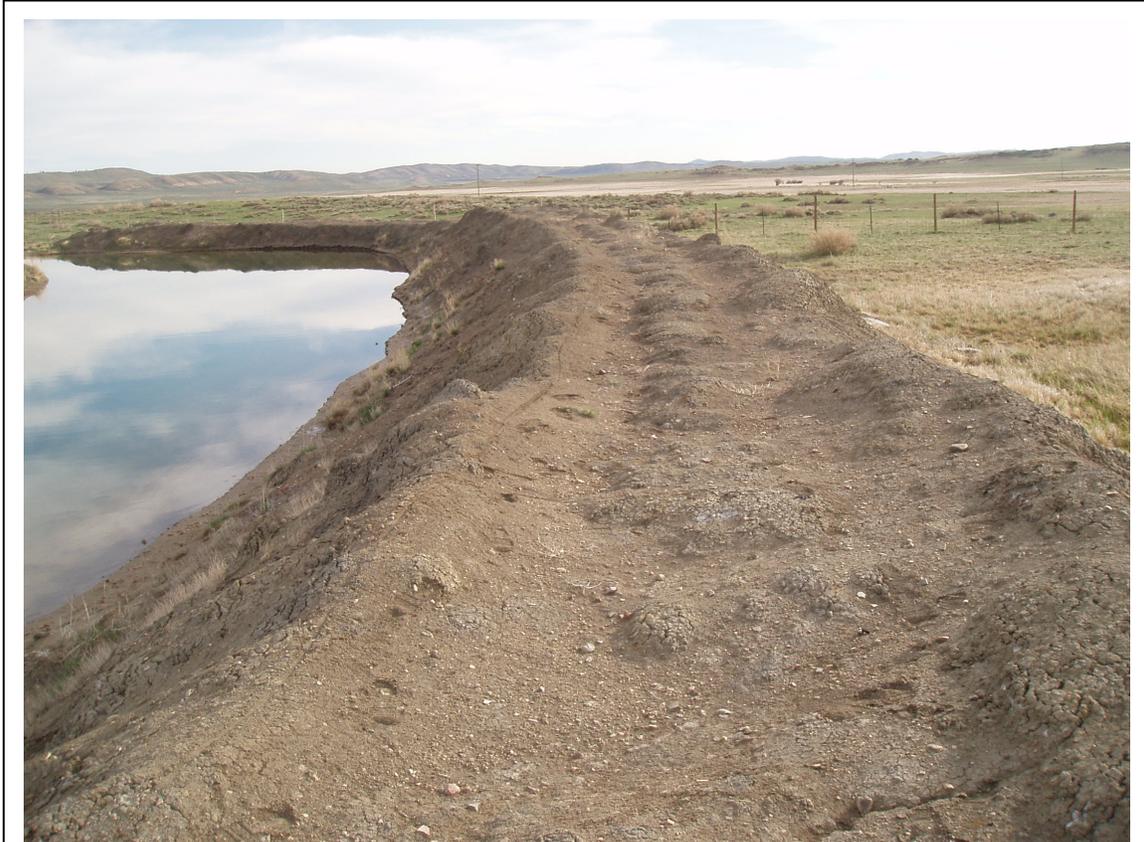
Photo 2: Spoils Pile and Eroding Bank at Eagle Lake.

Five of the lakes were excavator dredged in 2003, creating deep water trenches and islands along the edges of the water bodies. The spoils from the dredging apparently were not re-seeded, and this material is gradually eroding back into the lakes (Photo 2). Additionally, these disturbed areas have created opportunities for noxious weeds such as Canada thistle to become well established along the shorelines of most of these lakes.

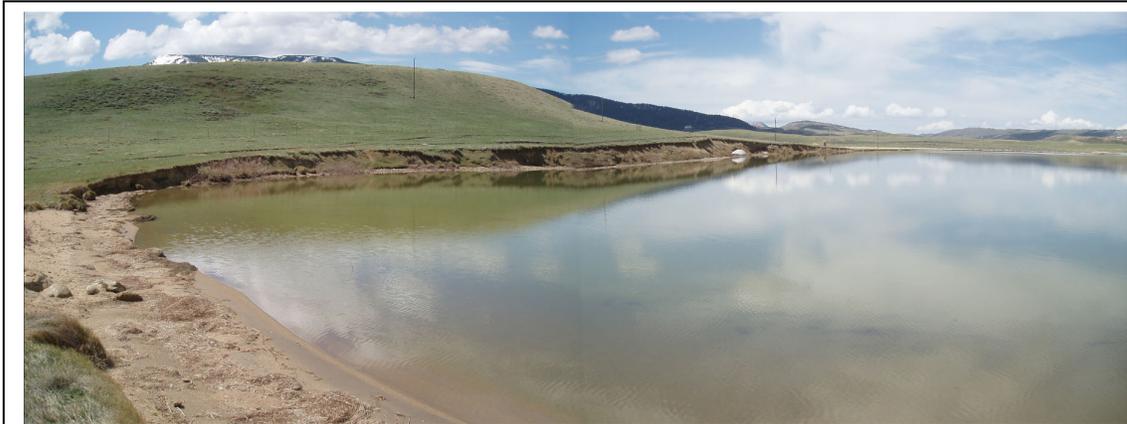
Photo 3: The actively eroding southern shoreline of Waken Tanka Lake.

All of the lakes exhibit some level of shoreline erosion due to wind and wave action along the leeward shores. In many instances, this shoreline erosion is further filling in important lake habitat and needs to be stabilized (Photo 3). Additionally, many of the islands constructed during the 2003 dredging effort are extremely unstable, and continue to erode back into the lakes. A site survey in early May 2007, was conducted to identify and measure the length of shorelines requiring treatment.

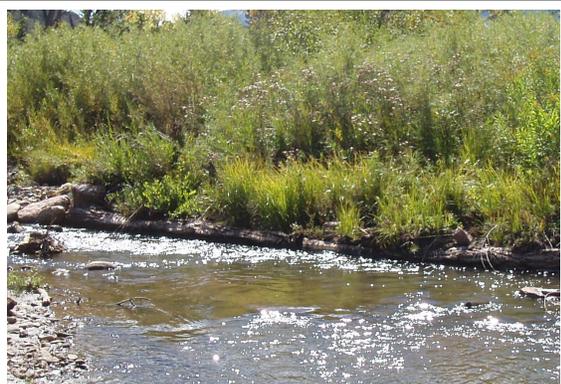
Photo 4: Log toe-slope stabilization of a stream

Root-wad revetments and log toe-slope stabilization techniques are useful for hardening of the shoreline to protect from erosive wave action. These areas may be treated using large wood to create a stable toe and full-pool bench on the bank, then the upper portion of the bank may sloped back and revegetated (Photo #4)(Drawings 10 & 11 - Appendix). The full pool bench should be revegetated using locally available willow and sedge mats harvested from areas nearby the site. Root-wads and trees can be obtained locally from harvest areas planned on the ranch. Mats of carex, rushes, sedge and willow will be selectively harvested from adjacent riparian areas and transplanted behind and on top of the root-wad revetments to create a natural looking and well armored shoreline. Estimated fill below the full pool watermark for this treatment is estimated to be less than 0.1 cubic yard / linear foot of lake shoreline. We propose to complete all of the shoreline stabilization and enhancement during the fall of 2007.

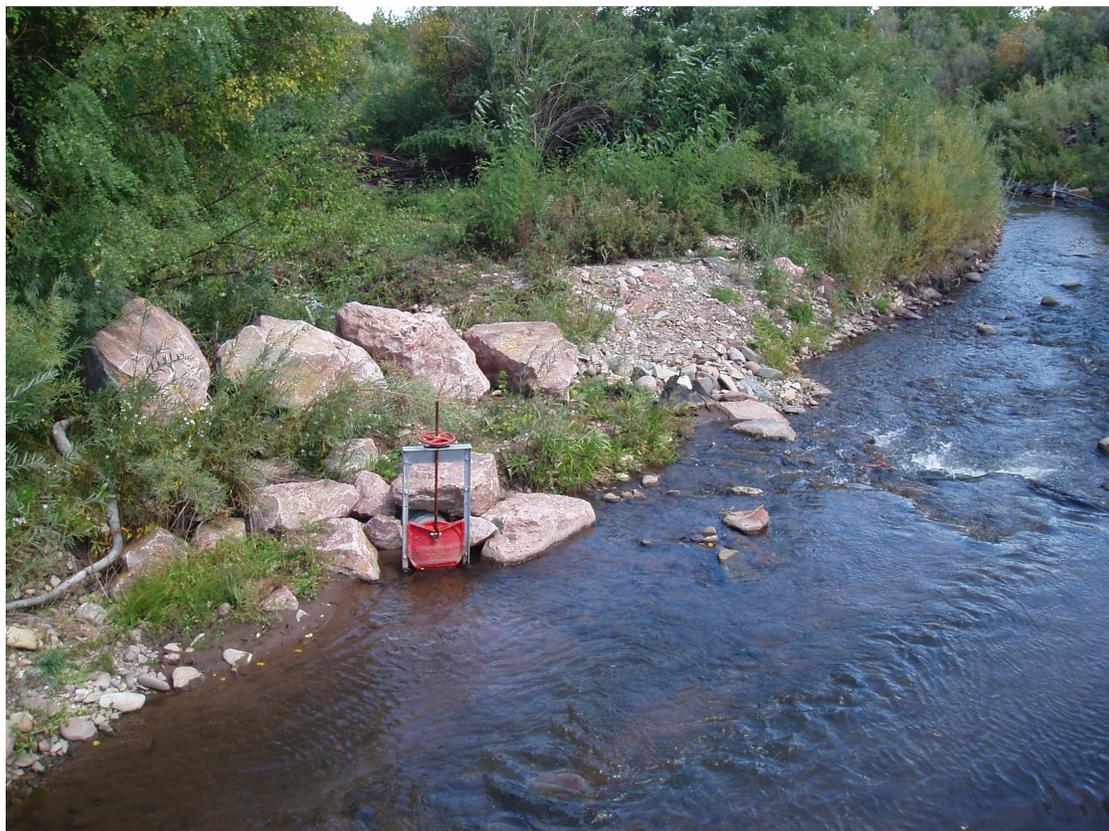
Photo 5: Typical 16" head-gate and culvert assembly, with a cross-vane immediately downstream. Cucharas River, Colorado..

Water depletion and evaporative loss are a significant limiting factor to several of the fishing lakes on the ranch. While most of the lakes exhibit an acceptable ratio of deep/shallow habitat at full-pool, all are habitat limited at the water levels observed during the August 2006 assessment (LSA, 2006). Trophy Lake and Swim Pond may benefit from additional water exchange through inlet and outlet enhancement. Improved flow into these lakes should improve overall water quality and reduce daytime temperatures. The capability of diverting water into Trophy Lake can be enhanced by installing a cross-vane at the diversion point on Halleck Creek and replacing the head-gate and cleaning the vegetation out of the inlet ditch.

A 16" head-gate and twenty foot long culvert will be installed at the outlet of Arapaho Lake, at an elevation two feet lower than the lowest point of the existing channel. The old channel will be back-filled to a level 1 foot below the existing grade of the surrounding landscape, to allow for overflow in the event of a flood, and the shoreline will be armored with log toe-slope full pool bench structures and boulder.

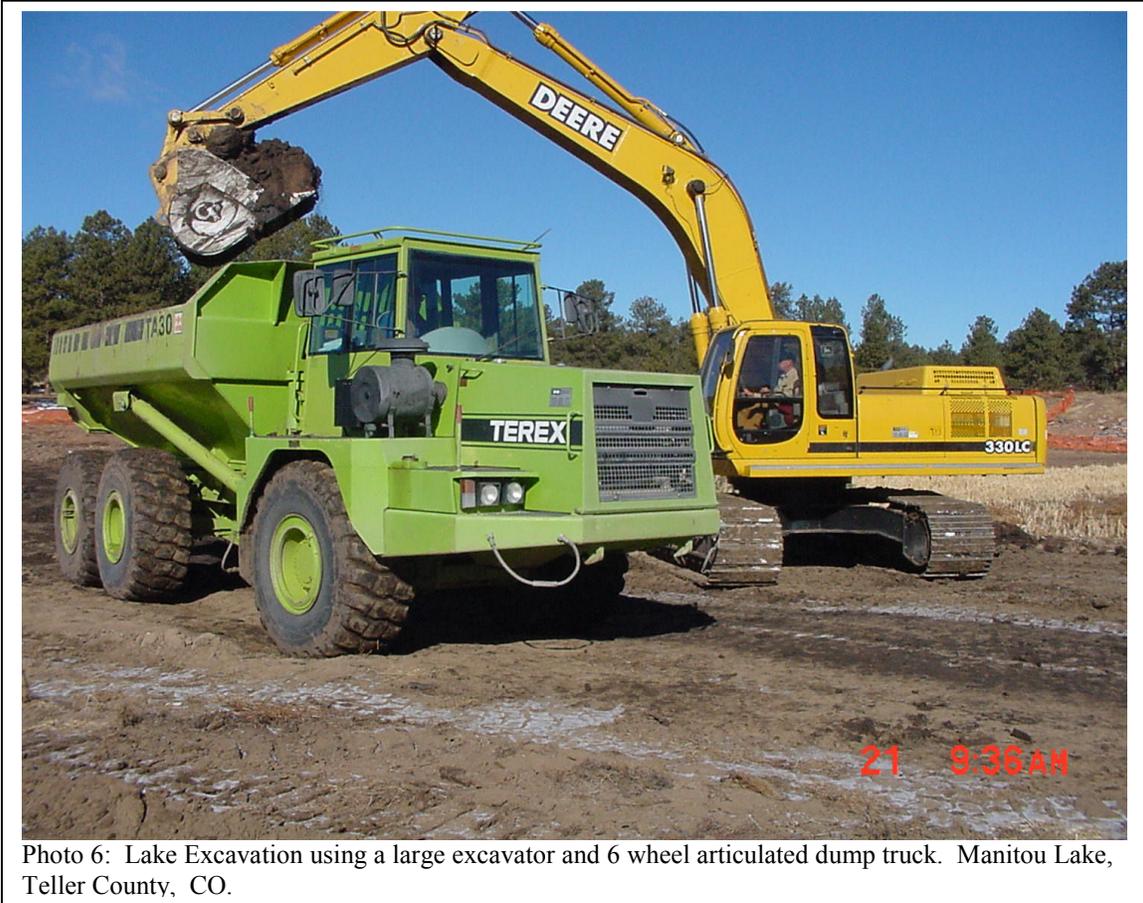
Photo 6: Lake Excavation using a large excavator and 6 wheel articulated dump truck. Manitou Lake, Teller County, CO.

Once the lake to be treated is drained, it will be allowed to dry out and freeze over the next two to three month period. Excavation of the lake bottom will be completed during late January, February and early March, using a large excavator with an 8ft. bucket. All disturbed spoils will be transferred directly into 18-20 yd³ six-wheeled articulated dump trucks or similar pieces of equipment (Photo 6), and hauled to designated storage sites on the property. It is anticipated that two or three of these vehicles will be operating continuously during the project.

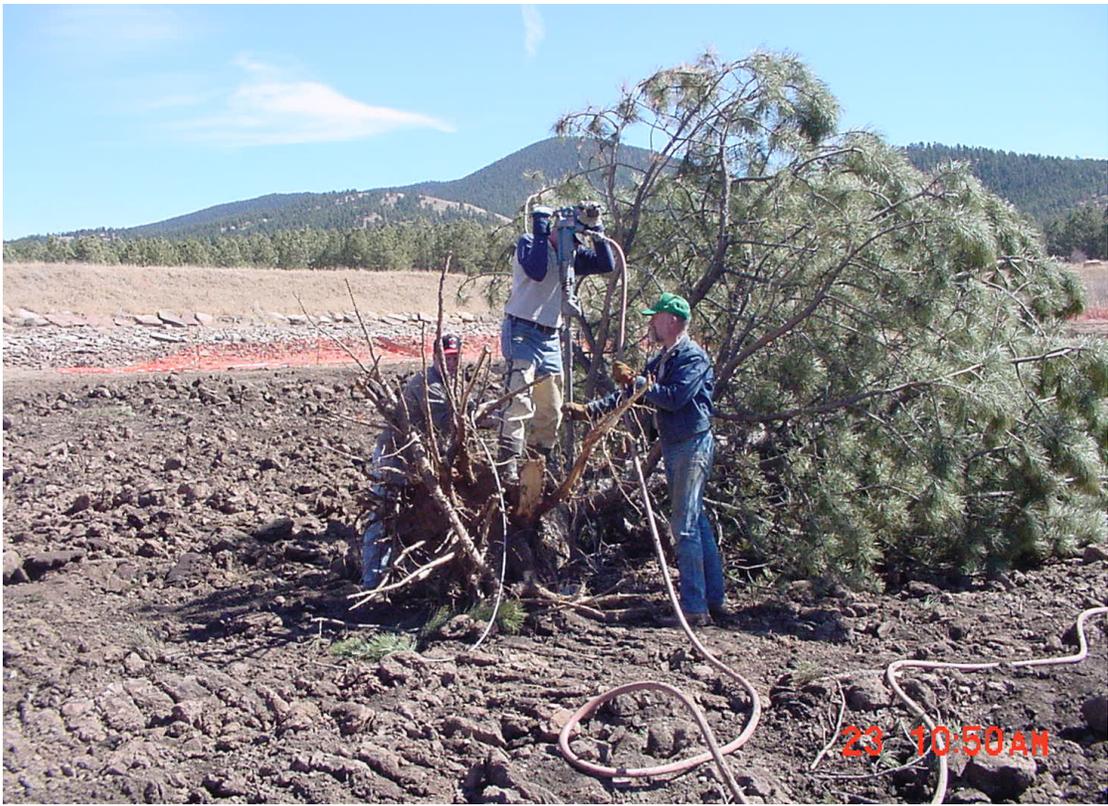
Photo 7: Trout Unlimited volunteers anchor a large pine in the lake bottom using a 90lb pneumatic drill and stainless steel Manta-Ray MR-1 anchors. Manitou Lake, Teller County, CO.

After each lake has been excavated, a few large trees may be anchored in the deeper areas, using Manta-Ray or similar dead-man anchors to prevent the trees from floating to the surface (Photo 7). These trees will add important habitat complexity and cover for smaller juvenile fishes and forage organisms. A few boulder clusters may also be considered if boulders are remaining from the shoreline stabilization work.

After the lake has been excavated, a few large trees may be anchored in the deeper areas, using Manta-Ray or similar dead-man anchors to prevent the trees from floating to the surface. These trees will add important habitat complexity and cover for smaller juvenile fishes and forage organisms.

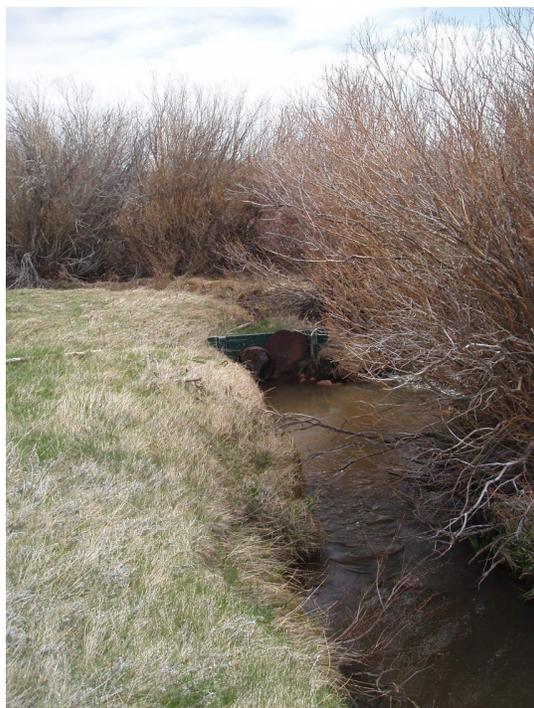
Photo 8: Existing Trophy Lake Diversion

The existing inlet ditch from Halleck Creek to Trophy Lake has become overgrown with vegetation, and is barely defined near the inlet with the lake. The diversion at Halleck Creek is in poor condition (Photo 8), and does not appear to function well at base flows typically found during the late summer and fall. The inlet ditch is 2,038 ft long and averages approximately 1 foot in width. The slope of the existing channel is approximately 1%.

A boulder cross-vane structure will be constructed immediately downstream of the existing diversion on Halleck Creek. The cross vane will require 20 to 25 large boulders, and will raise the base flow stage of the creek at the diversion point by approximately 0.4 feet, ensuring that the diversion can be utilized throughout the base flow periods in late summer and fall. Boulders will be harvested from the Rattlesnake Pass and 4 Corners areas identified in the Lower Rattlesnake Creek Restoration Plan (FIN-UP, Inc., 2007). A 16" head-gate and twenty foot long culvert will be installed at the diversion, replacing the existing sliding gate that is in disrepair. The culvert will be back-filled to the existing grade of the surrounding stream bank, and the head-gate will be armored with boulder to sustain above bank-full flows without overtopping.

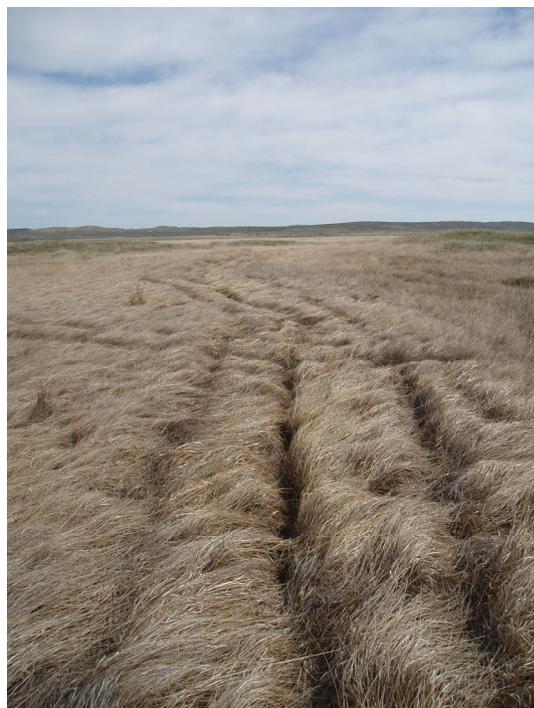
Photo 9: Diversion ditch to Trophy Lake..

The inlet ditch (Photo 9) between the diversion structure and Trophy Lake will be cleaned of all vegetation and widened to approximately 2 ft. All vegetation harvested during the ditch cleaning will be utilized to establish vegetation along the newly constructed shoreline stabilization structures.

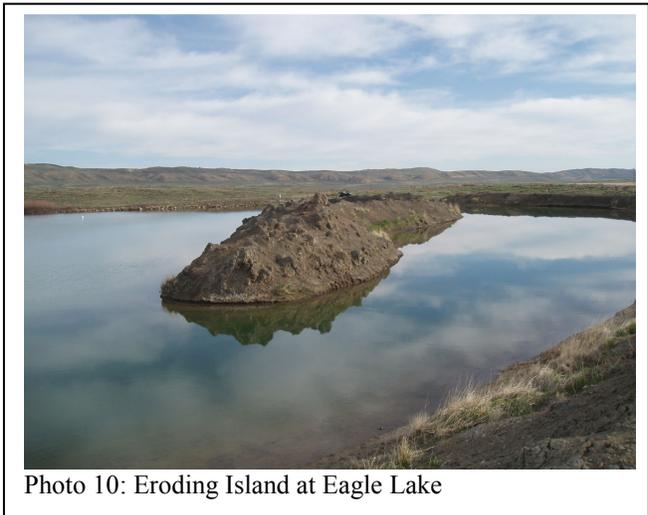
Photo 10: Eroding Island at Eagle Lake

Eagle Lake exhibits severe erosion along its north and east shorelines, and along the west shore of the island constructed on the east side of the lake. The island is particularly unstable (Photo 10), and is rapidly eroding back into the lake. Spoils piles left over from the 2003 dredging are collapsing into the lake, and need to be shaped, graded, and re-seeded, with excess spoils being hauled to one of the borrow pits identified in this document, or used to stabilize the erosion gullies on the downstream face of the dam. Approximately 5,725 yd³ of material will need to be removed from the eastern shore of the lake. The island elevation will be lowered approximately 4 - 5 feet, matching the existing landscape elevation of the shorelines, requiring removal of another 1,060 yd³ of materials. Approximately 550 feet of the lake shoreline along the east shore will need to be treated using the log toe slope stabilization. Another 300 feet of similar shoreline treatments will be installed on the west shoreline of the island once the excess materials have been removed (Map 5).

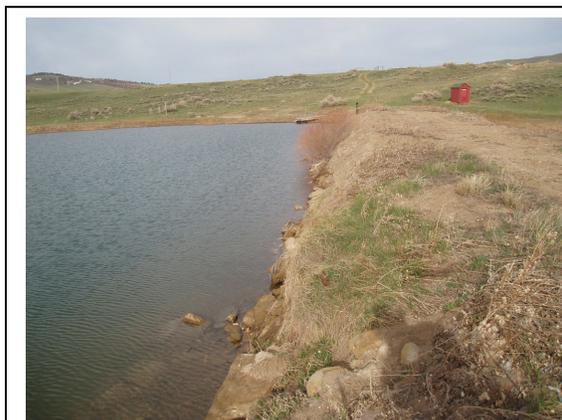
Photo 11: Lakeside Dam Face.

The lakeside face of the earthen dam on the north shore of Eagle Lake is in relatively poor condition, with several slope failures apparent along the length of the dam (Photo 11). Additionally, several gullies have formed on the downstream side of the dam (Photo 12), and will need to be treated in order to ensure the integrity of the structure. While the dam is not large enough to be considered "jurisdictional", it is still recommended

that best management practices for this type of structure be followed, including removal of deep rooted woody vegetation along the faces of the dam. We recommend harvesting willow and other woody species from the dam and using these plants for shoreline re-vegetation along the eastern shore of the lake. Approximately 1,800 yd³ of 12" - 16" rip-rap will be placed along the lakeside face of the dam to provide armoring of the shoreline and stabilization of the dam face. Rip-rap does not appear to be readily available on the ranch, and may need to be purchased from a nearby quarry and hauled to the site.

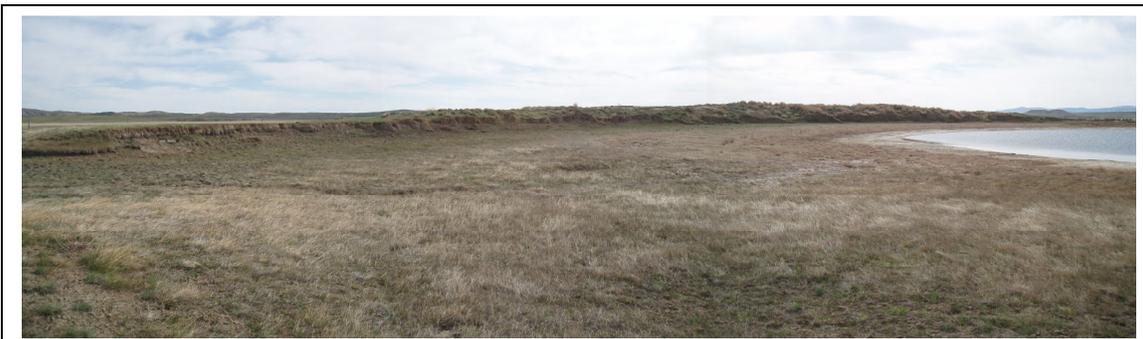
Photo 13: North shoreline of Tatanka Lake

Tatanka Lake exhibits severe erosion along its north, east, and south shorelines, and along the north shore of the island constructed on the south side of the lake (Photo 13). Four shoreline segments, totaling

approximately 1,550 feet of the lake shoreline will need to be treated using root-wad revetment and log toe slope stabilization techniques (Map 6). Additionally, the steep, unvegetated slopes above the eroding shorelines on the north and southeast shore of the lake need to be pulled back, re shaped and stabilized using either geo-textile or coconut jute fabric to allow vegetation to re-establish on these slopes.

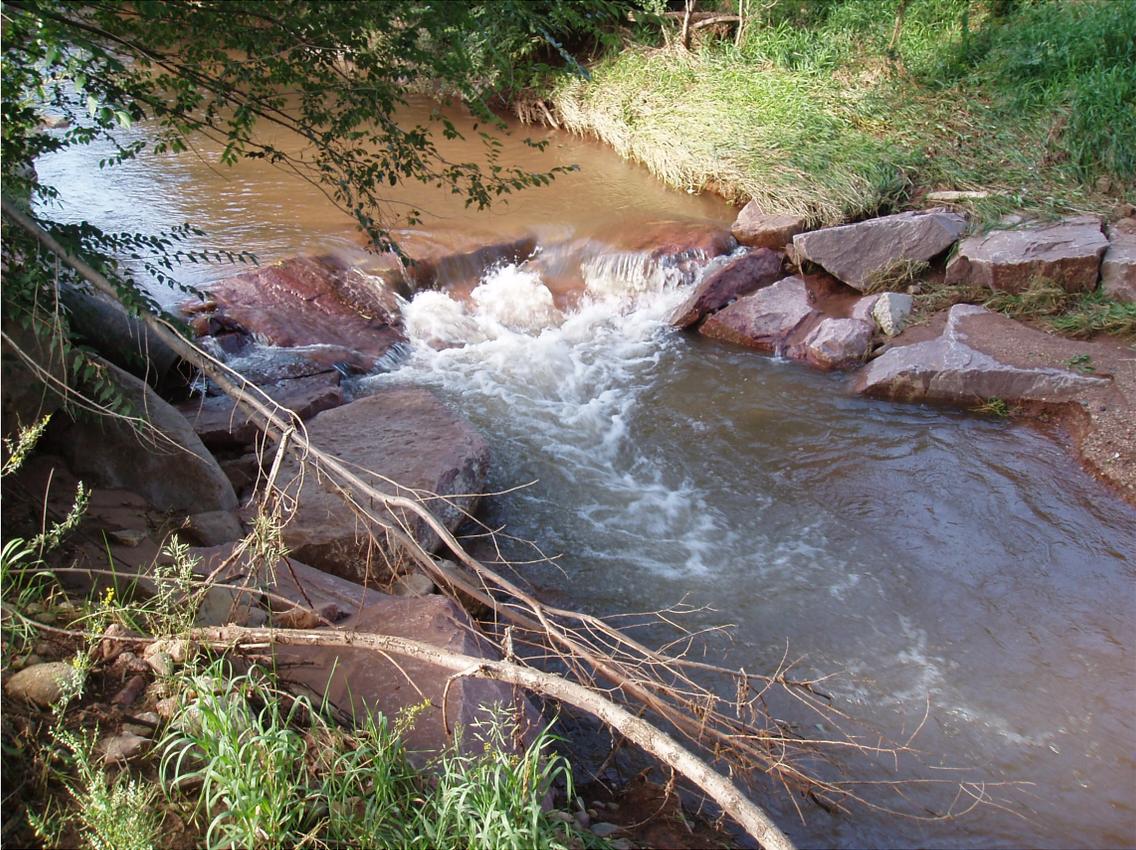
Cross Vane Structure on Fountain Creek below 21st Street Bridge, El Paso County, CO.

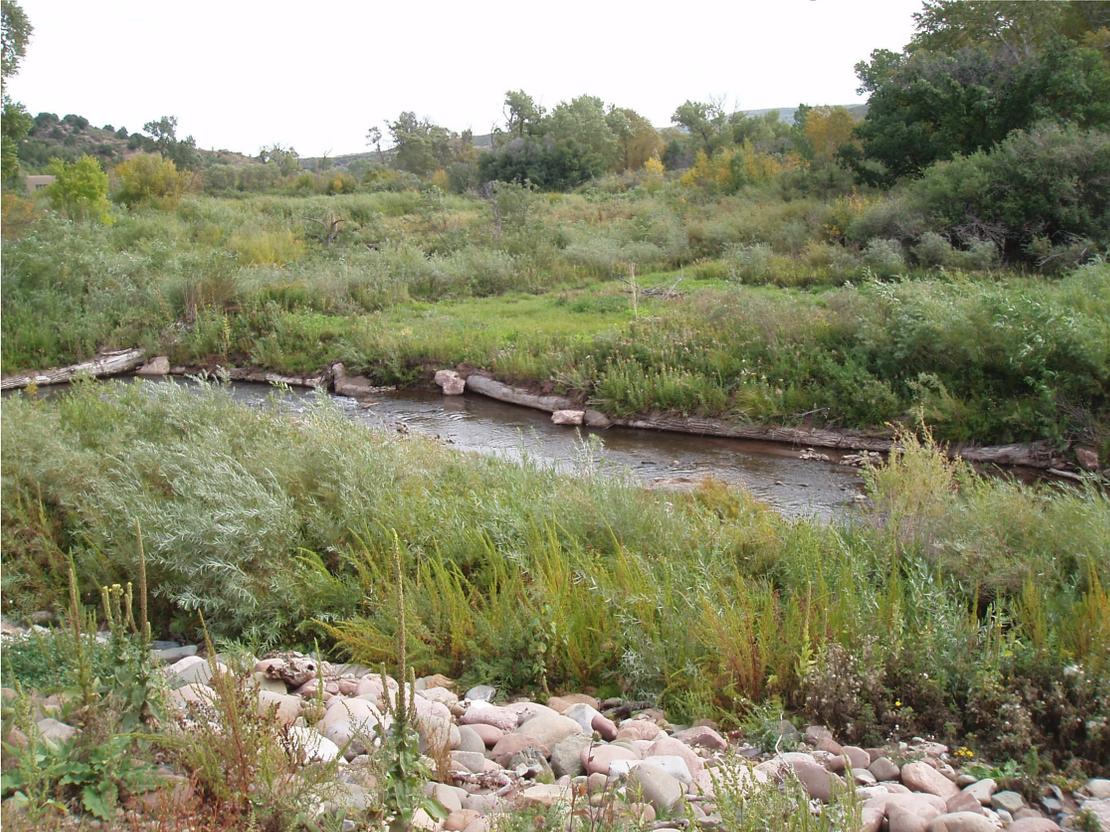
Cottonwood trees used as toe-slope stabilization with riparian benches. Cucharas Creek, Huerfano County, Colorado.
