PHOTOGRAPHS OF TREATMENT TYPES

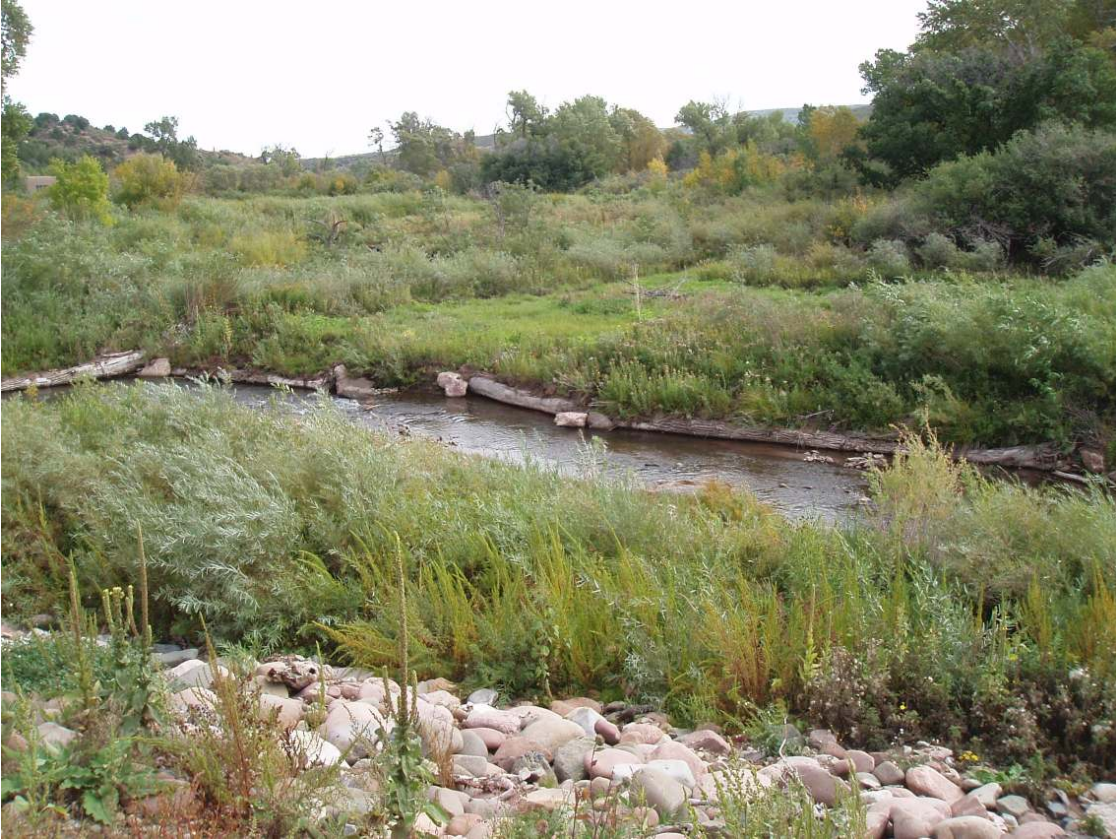
Cottonwood trees used as toe-slope stabilization with riparian benches. Cucharas Creek, Huerfano County, Colorado.
