Aquatic Assessment
&
Habitat Enhancement Plan
Fountain Creek - Soda Springs Park
City of Manitou Springs
El Paso County - Colorado

FIN-UP Habitat Consultants, Inc.

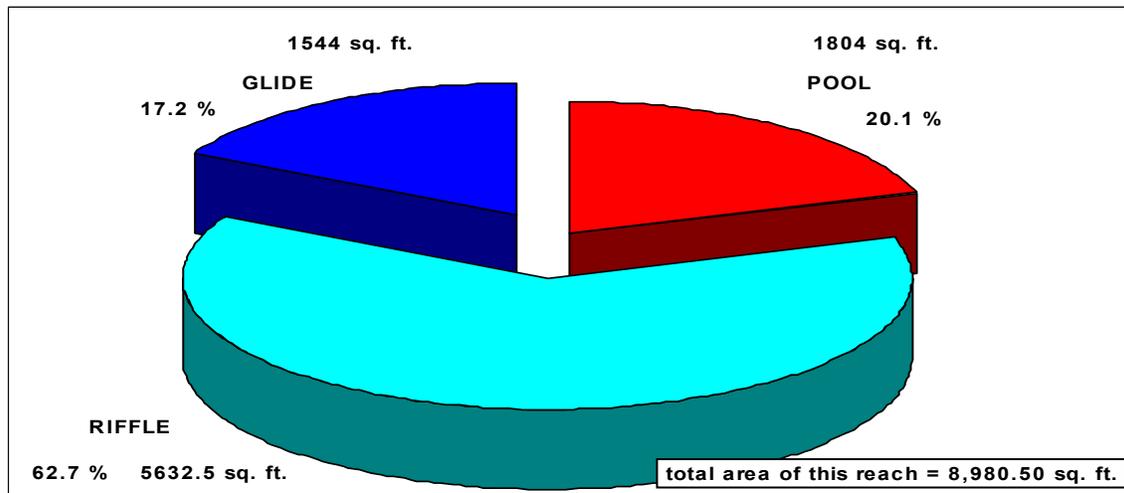
Chart 1 - Distribution of Pool, Riffle and Glide habitats in Reach 11 of Fountain Creek.

There were 27 individual meso-habitats measured in the reach (10 pools, 12 riffles and 5 glides), along a length of 765 feet of stream, and comprising a total wetted area of 8,980ft². The total area of the reach consisted of 63% riffles and 17% glides, with the remaining 20% consisting of pool habitat (Chart 1). The average wetted width of the stream was 11.2 feet throughout the reach. Due to the presence of the concrete retaining walls, approximately 80% of the stream banks were found to be stable. Stream bank stability outside of the segments confined by retaining walls was exceptionally poor, consisting mostly of bare slopes comprised of sand and gravel sized fragments. There were 225 feet of actively eroding stream banks contributing sediment directly into the stream. This accounted for slightly more than 15% of the total length of banks in the study reach.

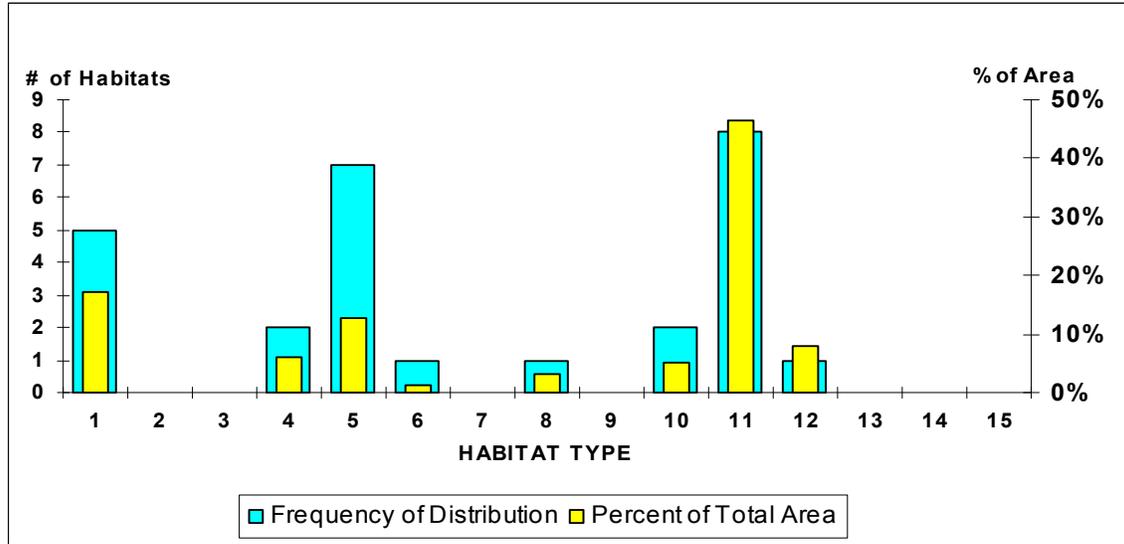
Chart 2 - Distribution of Meso-Habitat Types as a percentage of # of habitats and as a percentage of wetted perimeter of Reach 11 on Fountain Creek.

Low gradient cobble riffles were the most common habitat type in terms of numbers and area, accounting for 46% of the total reach area (Chart 2). Low gradient riffles can provide good spawning habitat, but are somewhat limited in terms of cover from high flows and predators. Two higher gradient, pocket water dominated riffle types were observed in the reach. Overall, very little cover for trout was observed in the riffles, amounting to less than 0.6% (20 ft²) of the total wetted area of these habitat types. The average width of all the riffles observed in the reach was 11.5 feet.

Pool habitat is very limited in the reach, with plunge pools being the most abundant (Chart 2). The plunge pools in the reach are principally associated with log-drop structures and boulder, and comprised 13% of the total wetted area of the reach. One lateral scour pool and two trench pools were observed, but these habitats accounted for less than 6% of the total reach. All of the pools exhibited some degree of in-filling of sediment, mostly consisting of smaller particles of decomposed granite. Due to this in-filling of fines, the average pool depth in Reach 11 was barely more than 1/2 foot. Residual pool depth (RPD) in Reach 11 was found to range from 0.5 to 1.6 feet, with an

average of 1.0 foot throughout the reach. RPD in the reach is relatively poor, and may limit adequate over-wintering habitat for salmonids and other native species in this reach. Cover for trout accounted for 8% of the total wetted area of the pools, which is quite poor for a stream of this size. The average wetted width of all pool types found within the reach was 11.2 feet.

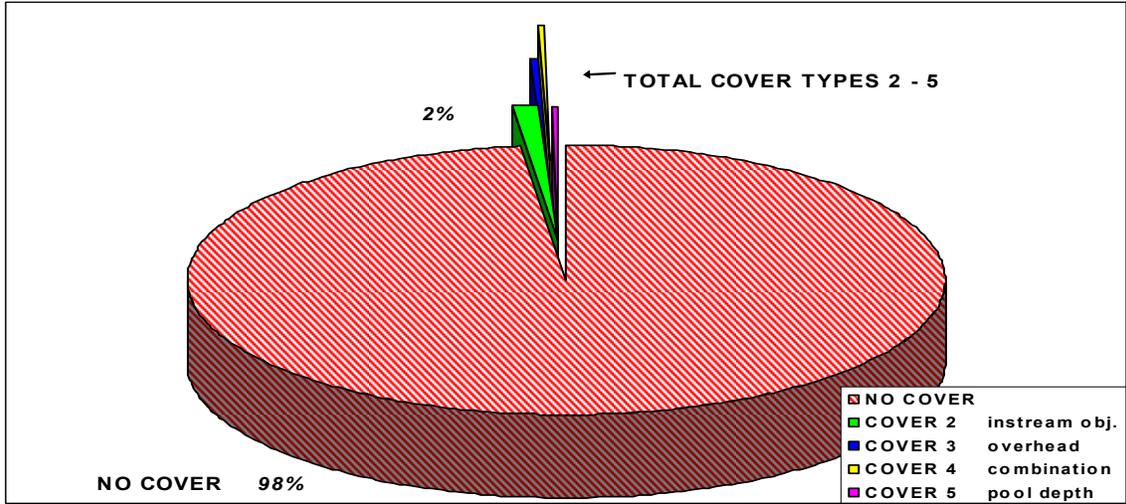
Chart 3 - Percentage of cover for trout to the total wetted perimeter Reach 11 on Fountain Creek.

Cover for adult trout accounted for fewer than 2% of the reach (Chart 3). Available cover appears to be a severely limiting factor to the health of the fishery, and will be addressed in the Habitat Enhancement Plan. Instream object cover (Cover Type 2 - >1' deep) was the dominant type observed in the reach, and was typically associated with the pool habitats. Pool cover (Cover Type 5 - >1.5'deep) was very limited in the reach, and comprised only 2% of the wetted area of the pools and 0.4% of the total reach area. Pool cover is an important indicator for determining the available over-wintering capacity of the stream reach, and appeared to be severely limited in this reach. Combination and overhead cover were the least abundant cover types, due to the lack of streamside vegetation and poor stability of the stream banks. Instream cover could be enhanced in the riffle habitats by adding structure and velocity shelters along the stream banks with strategically placed boulders and large wood. Pool cover may be increased by improving scour in existing pools as well as creating new pool habitats. Overhead and combination cover may be improved throughout the reach through stabilizing and revegetating the eroding stream banks.

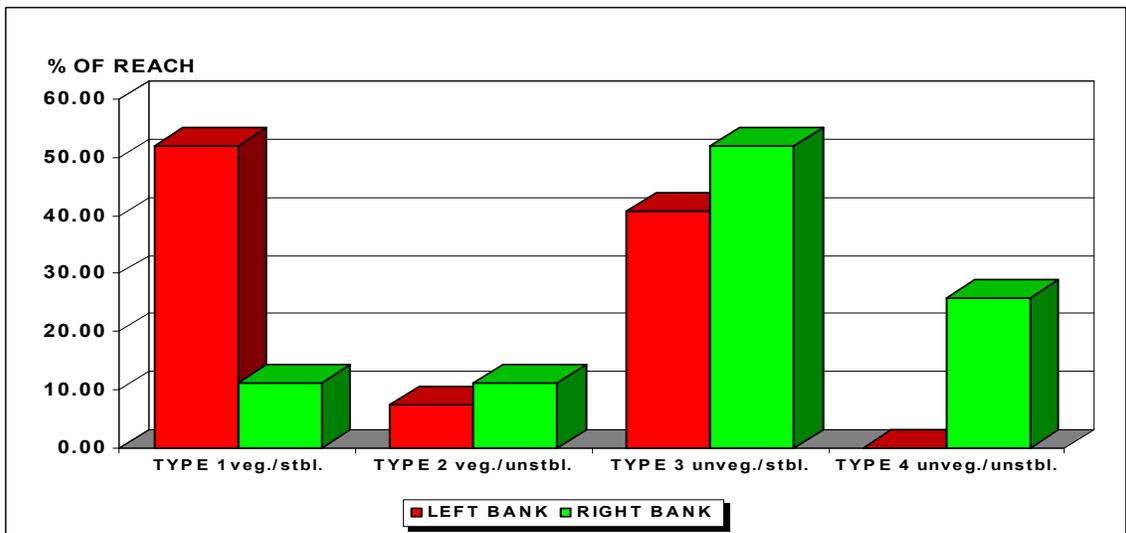
Chart 4 - Percentage of stable banks to unstable banks in Reach 11 on Fountain Creek.

In the segments not confined by concrete retaining walls, stream bank stability was generally poor, primarily due to lack of vegetation on the steep banks resulting from heavy recreational use. In segments of the reach where access is more difficult, such as the left bank at the steel foot bridge, the stream banks were generally in good condition. Deeply rooted, streamside riparian vegetation is a critical component in maintaining the integrity of stream banks during runoff and other high flow events. Fifty-two percent of the left bank and 11% of the right bank were found to be vegetated and stable. 41% of the left bank and 52% of the right banks were confined by concrete retaining walls. The remaining 7% of the left bank and 37% of the right bank were found to be unstable. (Chart 4). Bank rock content consisted either of concrete (Type 2) or mostly of sand and smaller fragments (Type 7), with small accretions of larger material and rip-rap (Chart 5).

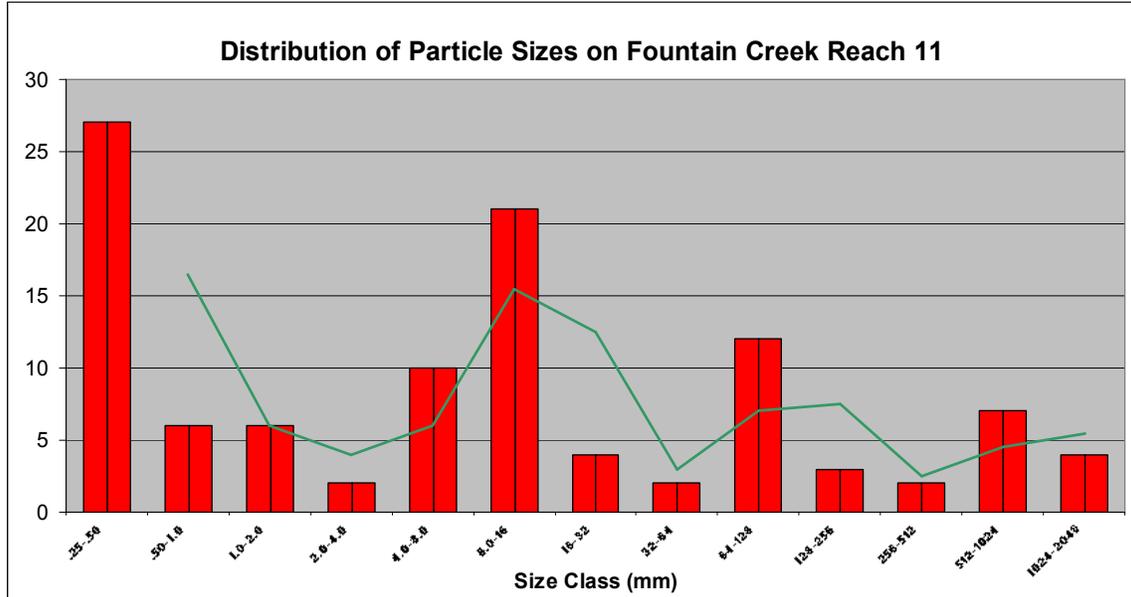
Chart 6 - Distribution of particle size classes distribution of sand and larger cobbles and boulder in Reach 11 on Fountain Creek.

The general reach substrate was calculated using a Wolman pebble Count (Beverger, 1997) and the results are shown in Table 2. A tri-modal distribution of smaller particles (fines) small gravel, and larger boulder is apparent in the pebble count data (Chart 6), and suggests that sediment inputs to the stream may exceed the capacity of the stream to move the material. Large wood (>4" diameter and > 3' long) is somewhat scarce in the reach, with only six pieces being observed. All of these pieces were associated with log-drop structures. Large wood is an important habitat forming component for rivers in the Rocky Mountains, and provides cover and complexity to the aquatic ecosystem, but may not be desirable for use in an urban environment such as Reach 11.

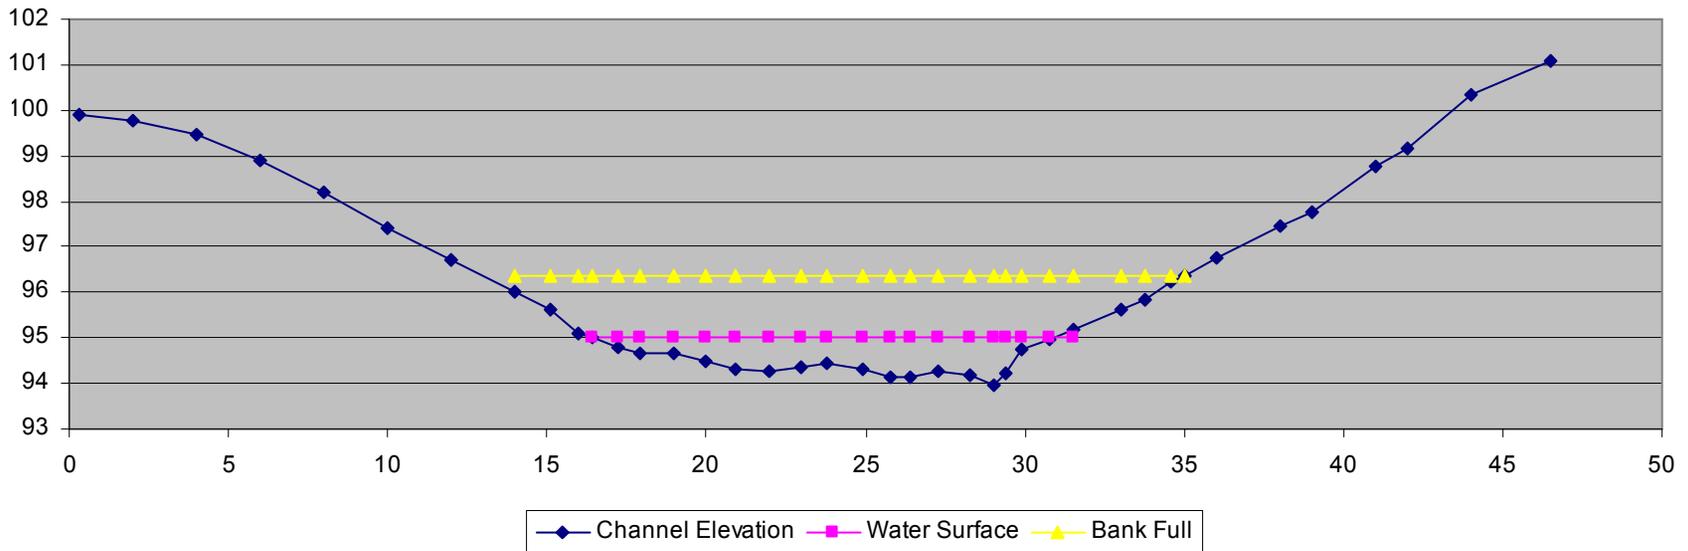
Cross Section #6 @ Glide 3 (Blown Out Drop Structure)

the inherent tendency of this structure type to over-widen the stream channel, these habitats occupy only a very small length along the stream channel. Additionally, one of these log drop structures currently protects a partially exposed utility pipe crossing the stream channel. The log drop structure immediately downstream of this structure has failed, causing the channel to head-cut back to this log drop structure. At present, the log drop is undercut approximately one foot, and is at risk of failure.

the failed drop log structure at Glide #3 will need to be reconstructed, as well as possibly another cross vane in Riffle #9, in order to create a stable, pocket water associated cascade between Riffle #10 and Glide #3. This work will not only protect the utility crossing, but will convert Glide #3 to pool habitat, and eliminate a potential migration barrier at the Pool #9 log-drop structure.

8. Reconstruct the failed log drop structure at Glide #3 through installation of a boulder cross vane. Excavate accumulated sediment from the pool and remove from the site.
